**Restoration of degraded coastal wetlands focusing on seagrass meadows in Gulf of Mannar, Tamil Nadu - *to strengthen climate adaptation and to enhance livelihood sustainability***

(Work Order: TNSWA1/25733/2022, Dated 12.02.2024)

## **Final Report**

**Suganthi Devadason Marine Research Institute (SDMRI)  
(Recognized by Manonmaniam Sundaranar University and U.G.C. &  
Recognized Scientific and Industrial Research Organization by the DSIR, GOI)**

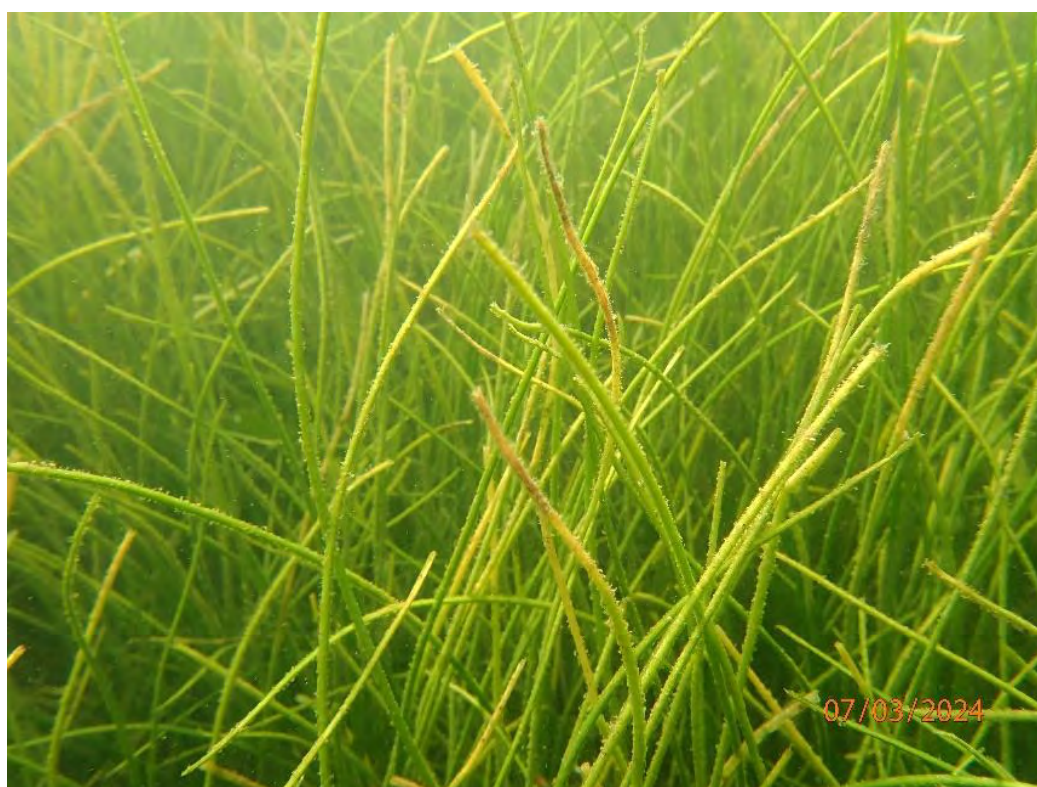
**Fig. 4: Donor site with healthy dense seagrass bed**

| Seagrass Donor site | GPS | Depth | Nearest Island | Distance from restoration site (km) | Donor site status | Dominant species |
| Near Tharuvaikulam village, Tuticorin coast of Gulf of Mannar | 8°53'5.88"N<br>78°11'35.17"E | 2.0 - 3.0 m | Koswari | 3.0 | Dense seagrass meadows | <i>Oceana serrulata</i> ,<br><i>Syringodium isoetifolium</i> ,<br><i>Thalassia hemprichii</i> ,<br><i>Halodule uninervis</i> |

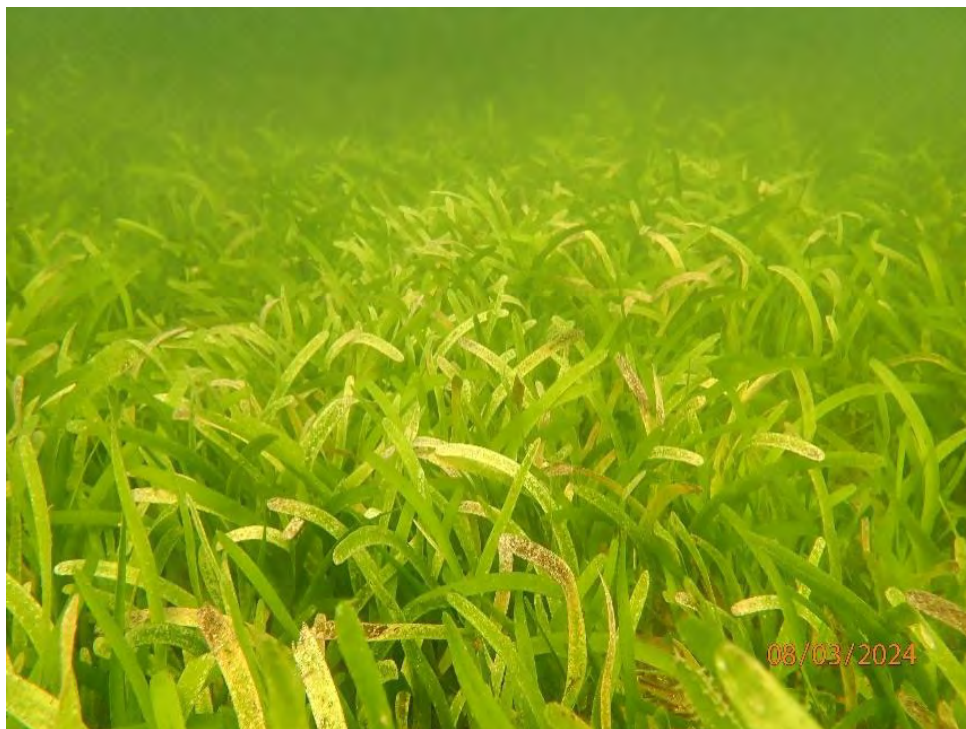
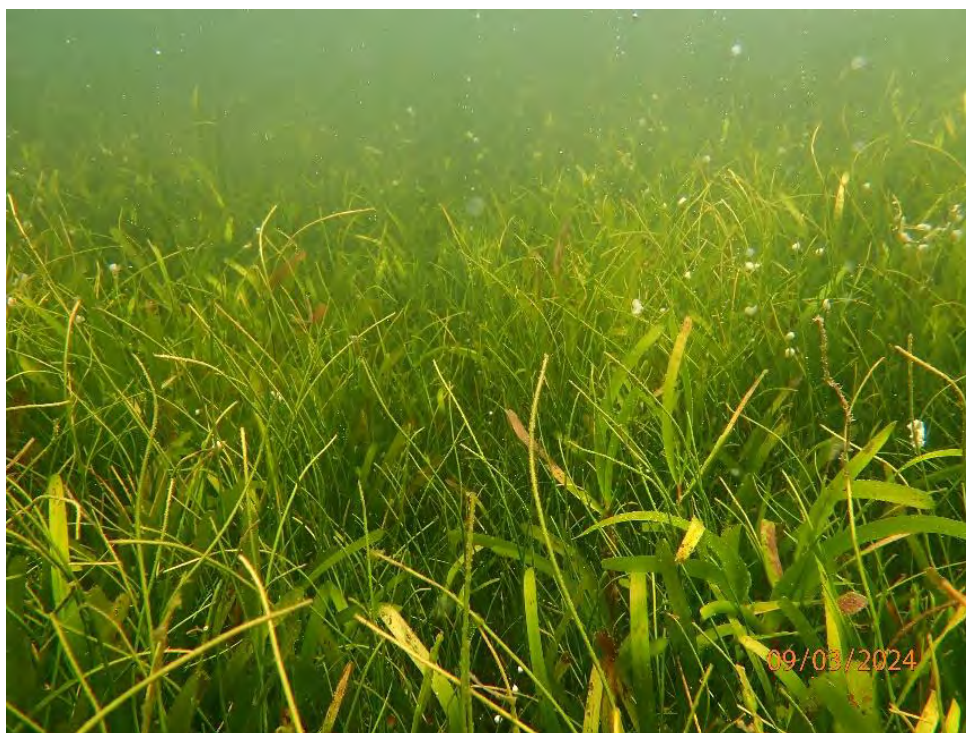
**Fig.5: Donor site with healthy dense seagrass bed**

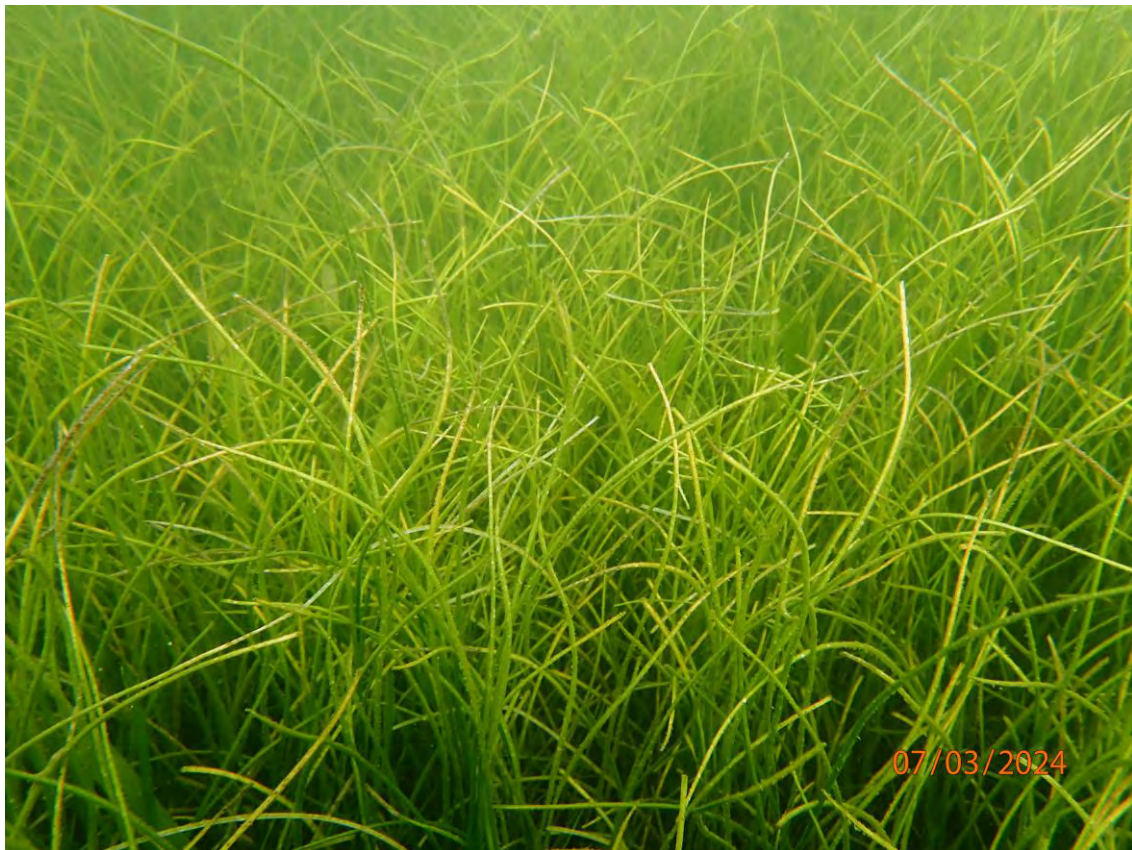
Cylindrical in cross section (spaghetti like); leaf tip tapers to a point; leaves 7-30 cm long; found on shallow subtidal reef flats and sand banks.

**Fig.8: *Syringodium isoetifolium***

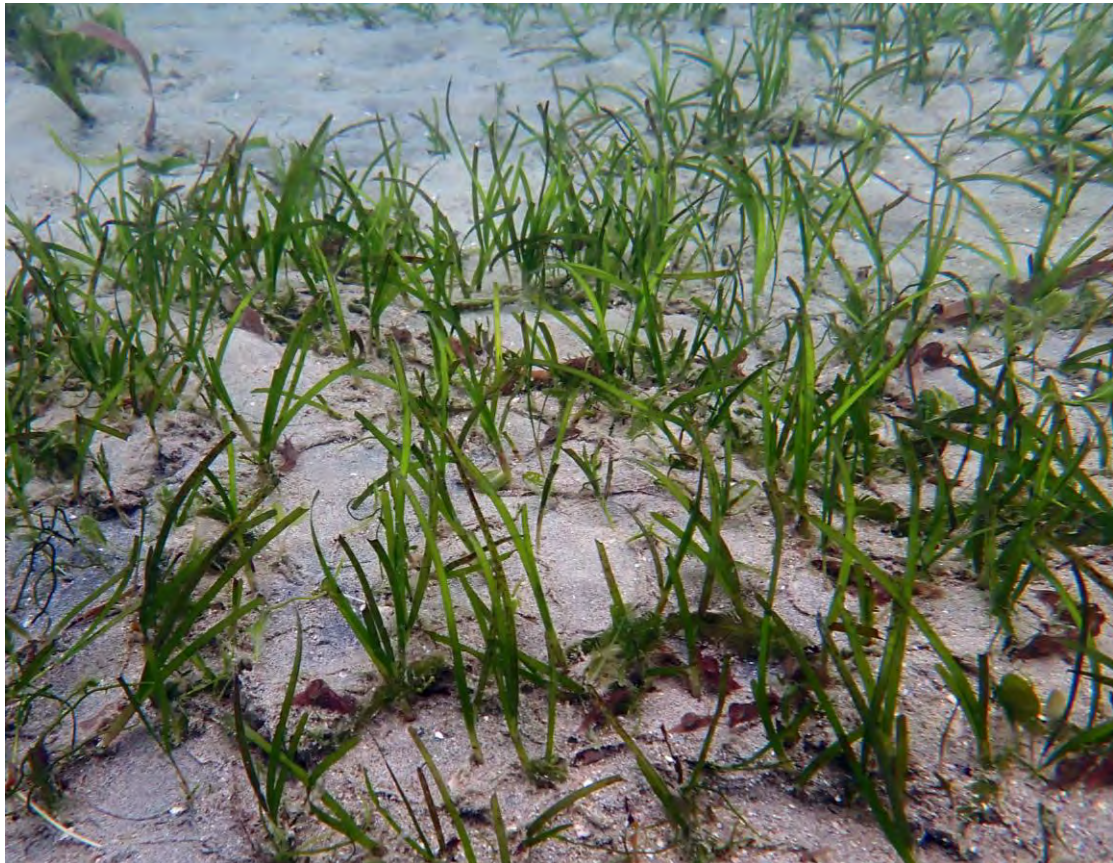
Usually larger than *Halodule pinifolia*; trident leaf tip; 1 central longitudinal vein; rhizome usually pale ivory, with clean black leaf scars; dugong preferred food; found on shallow/intertidal sand or mud banks.

**Fig.9: *Halodule uninervis***

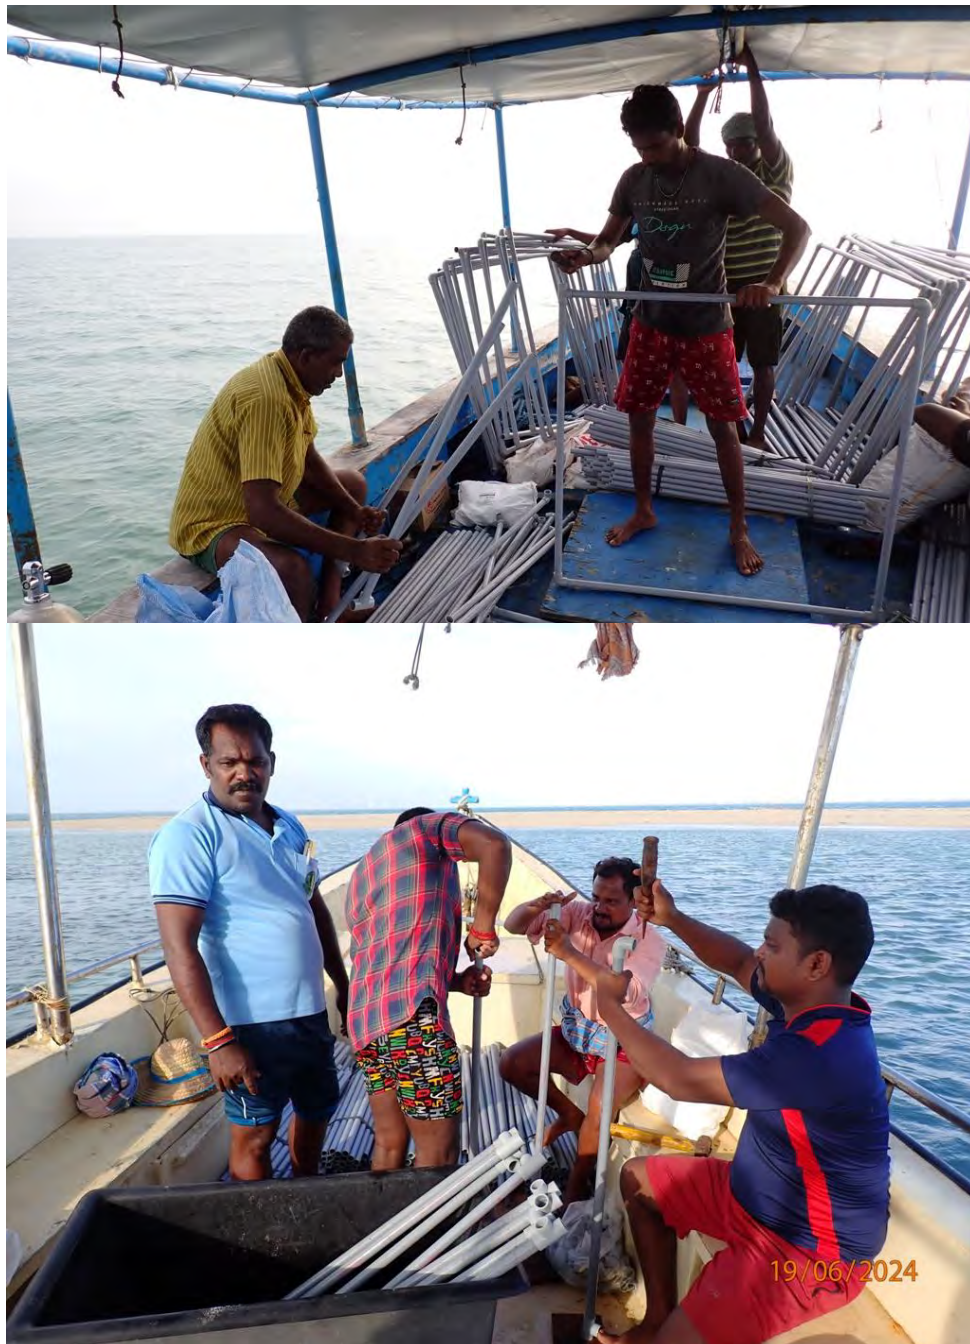
**Fig.13: Construction of PVC frames in the field**

Long PVC pipes were cut into desirable size to make 1 X 1 m frame. A total of 2,000 PVC frames (1 X 1 m) were fabricated. Initial work was done at the laboratory in Tuticorin and the final fabrication was completed in the field (Fig.13 & 14).

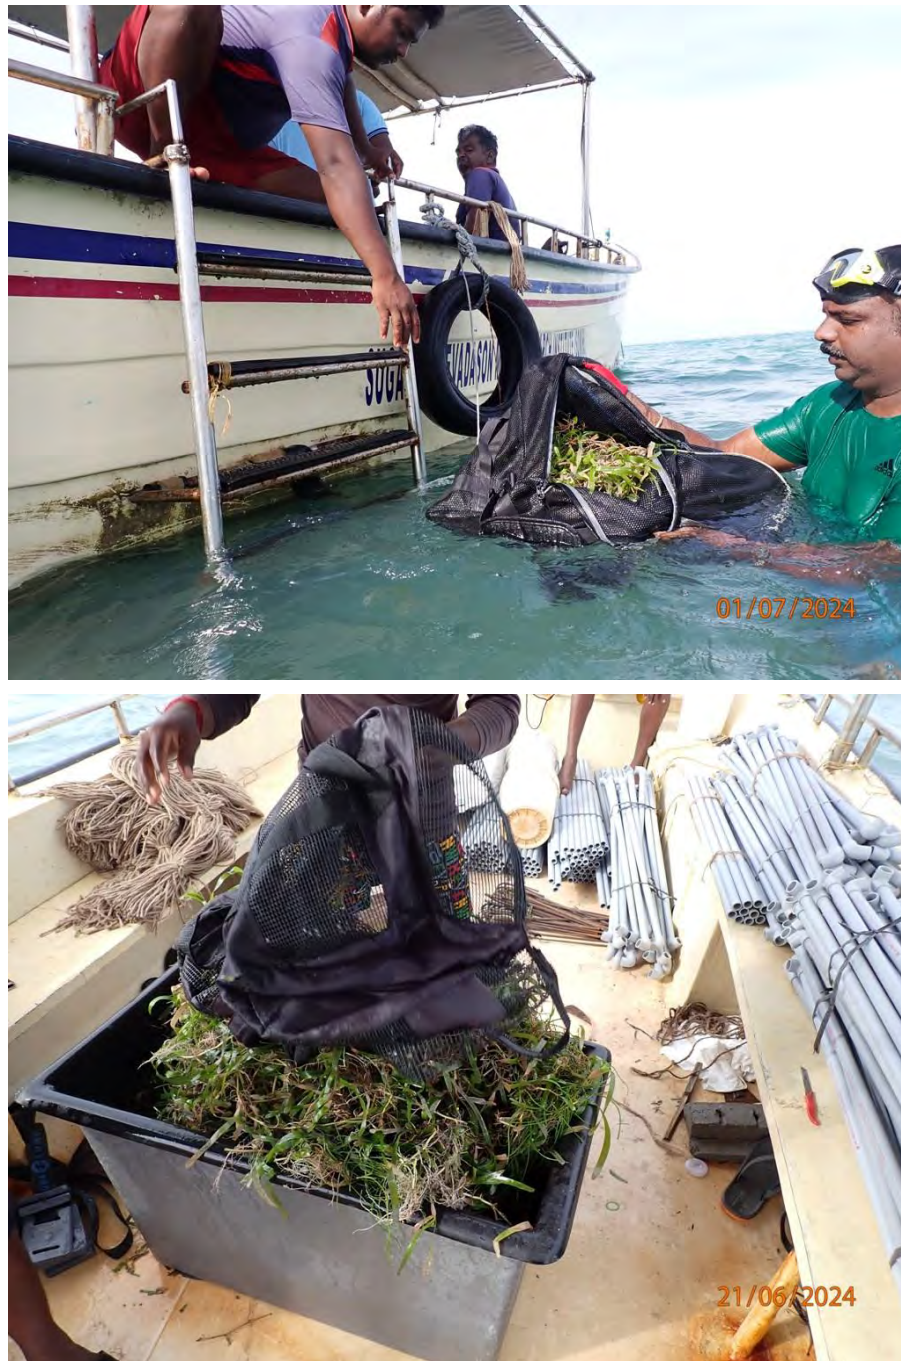
**Fig.15: Seagrass shoots collected from donor site for transplantation**

Four seagrass species (*Oceana serrulata*, *Thalassia hemprichii*, *Syringodium isoetifolium* and *Halodule uninervis*) were collected from the nearby healthy and dense donor seagrass beds. Due care was taken not to disturb the donor seagrass beds and also not to waste seagrass shoots (Figs.15- 18).

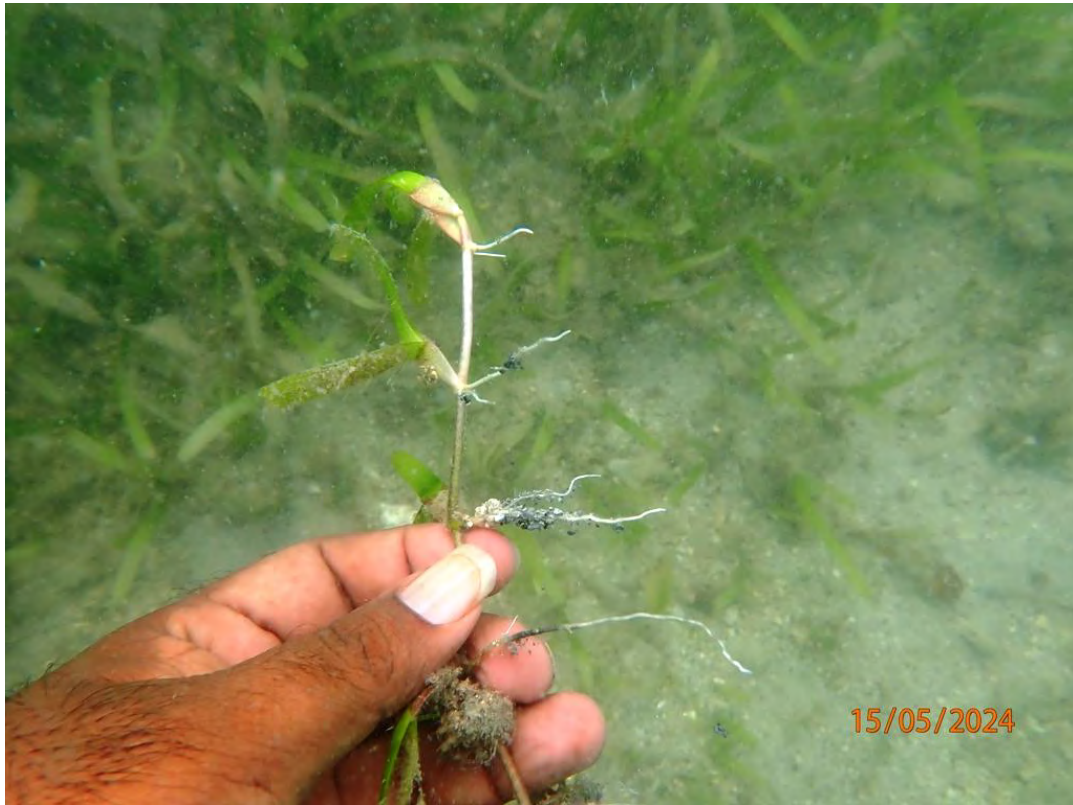
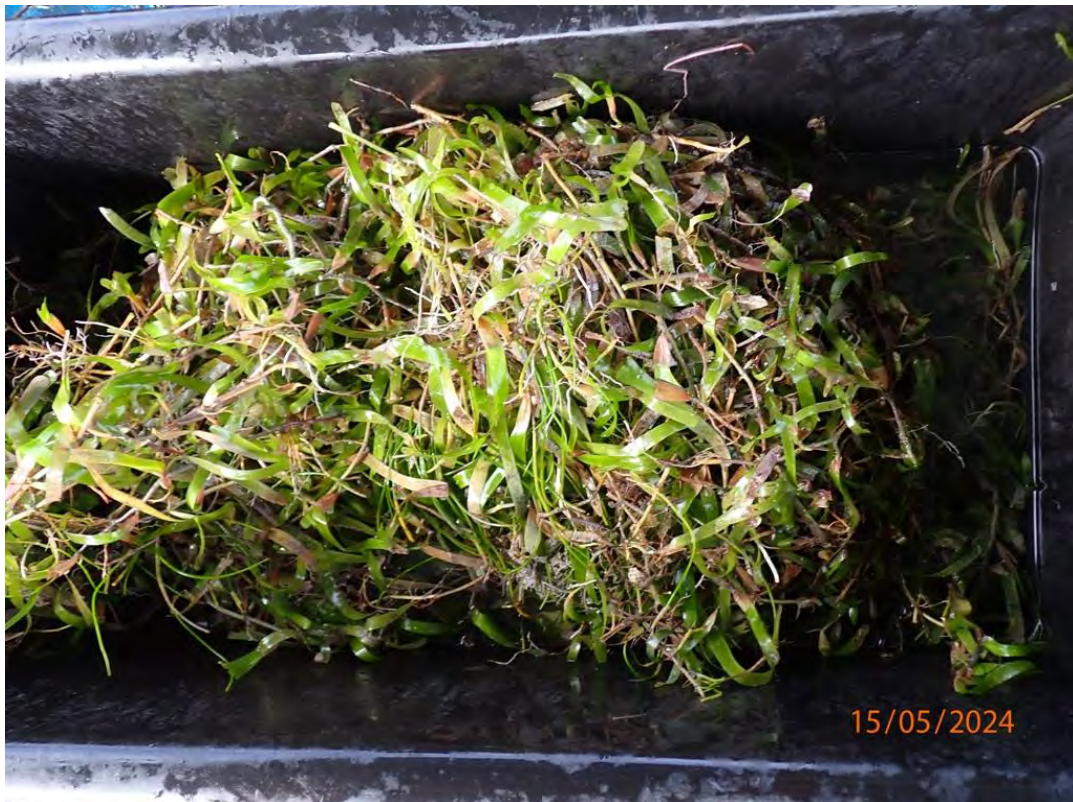
**Fig.16: Seagrass shoots collected from donor site for transplantation**

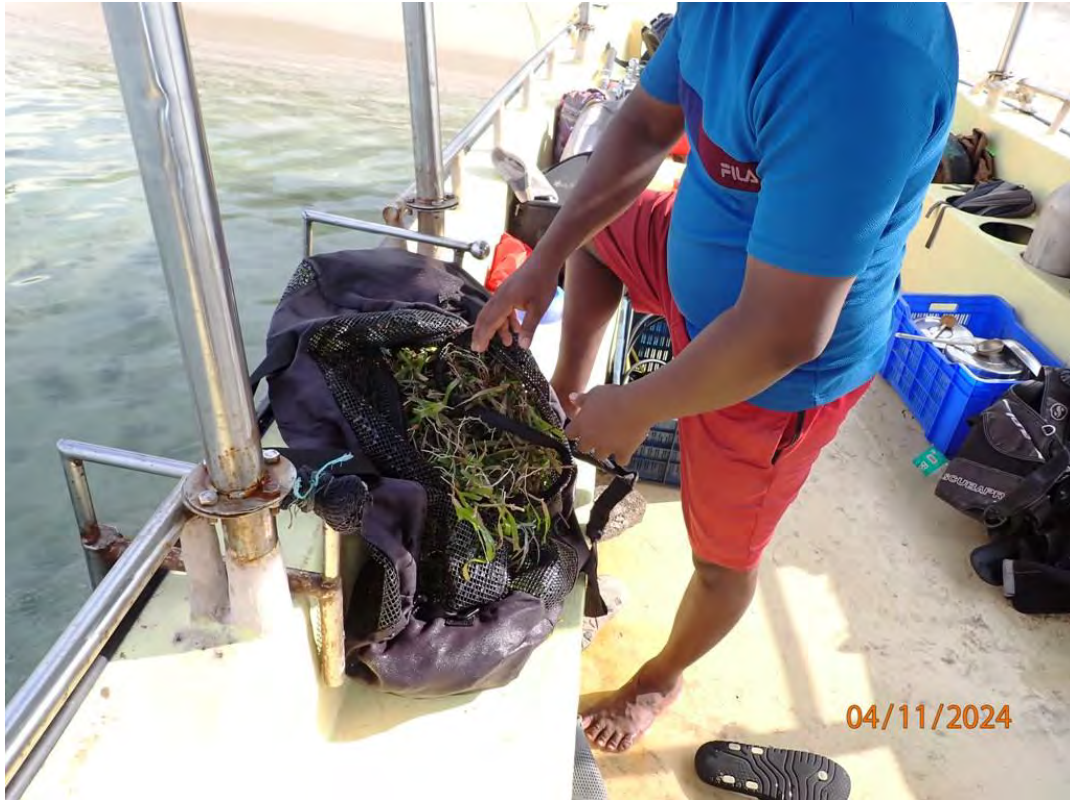
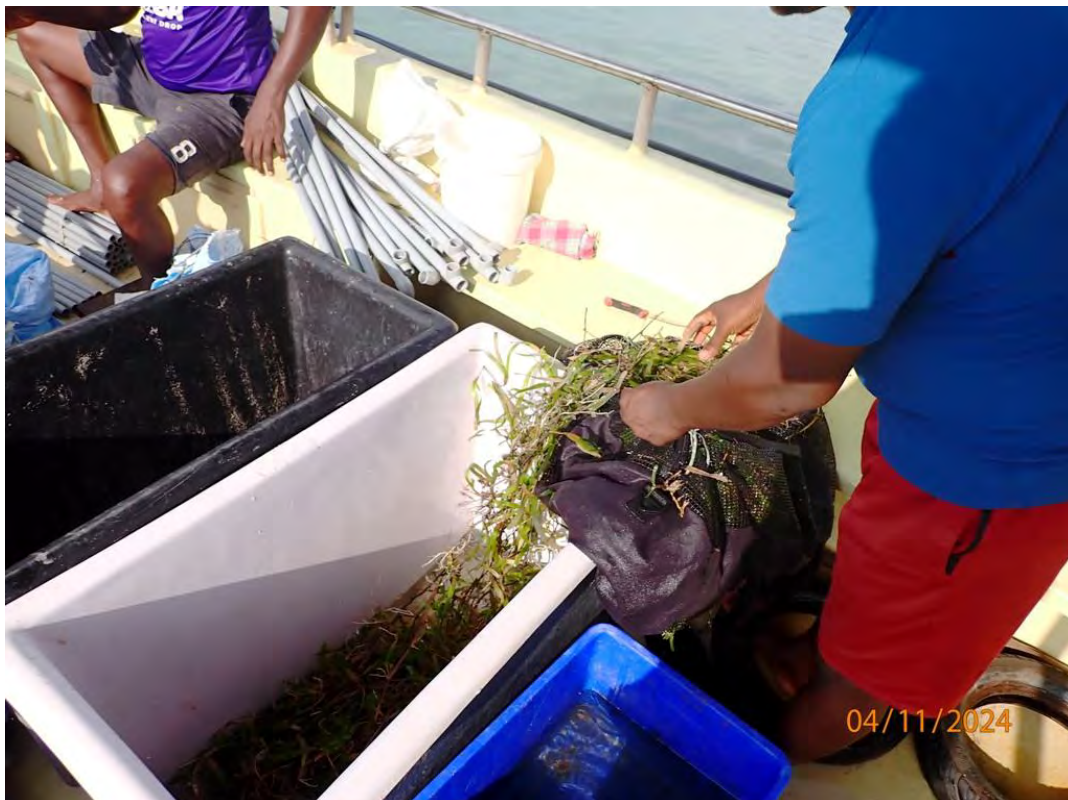
**Fig.17: Seagrass shoots collected from donor site for transplantation**

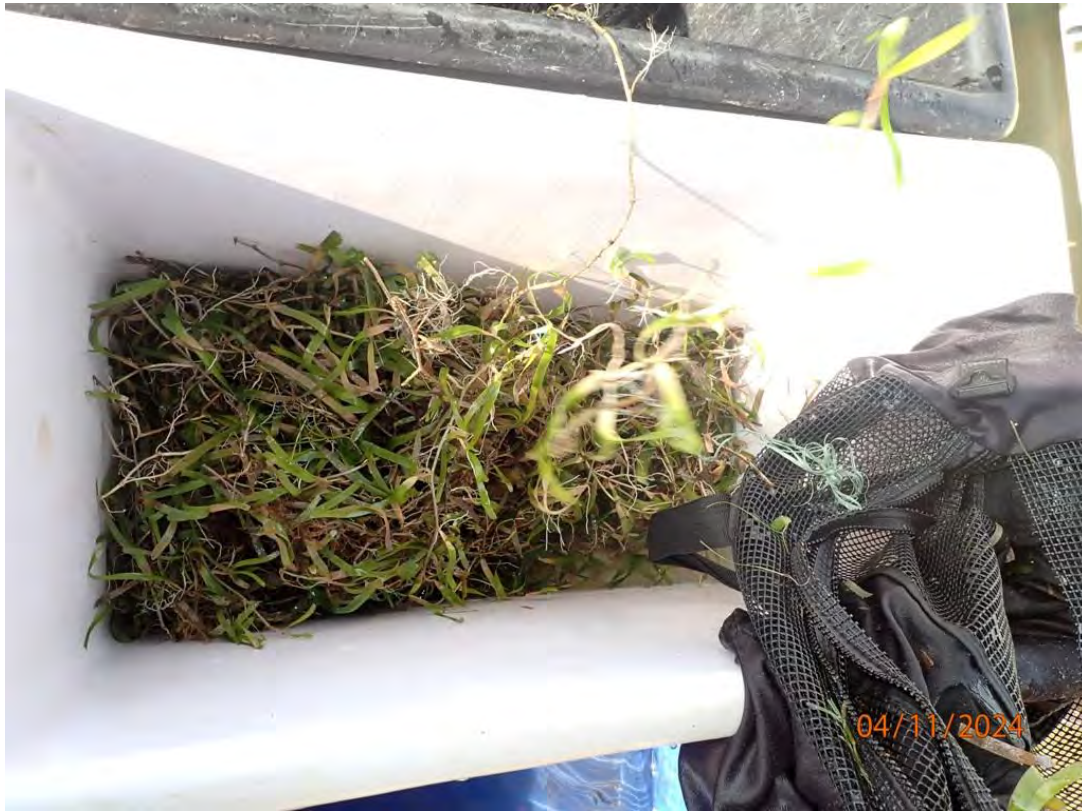
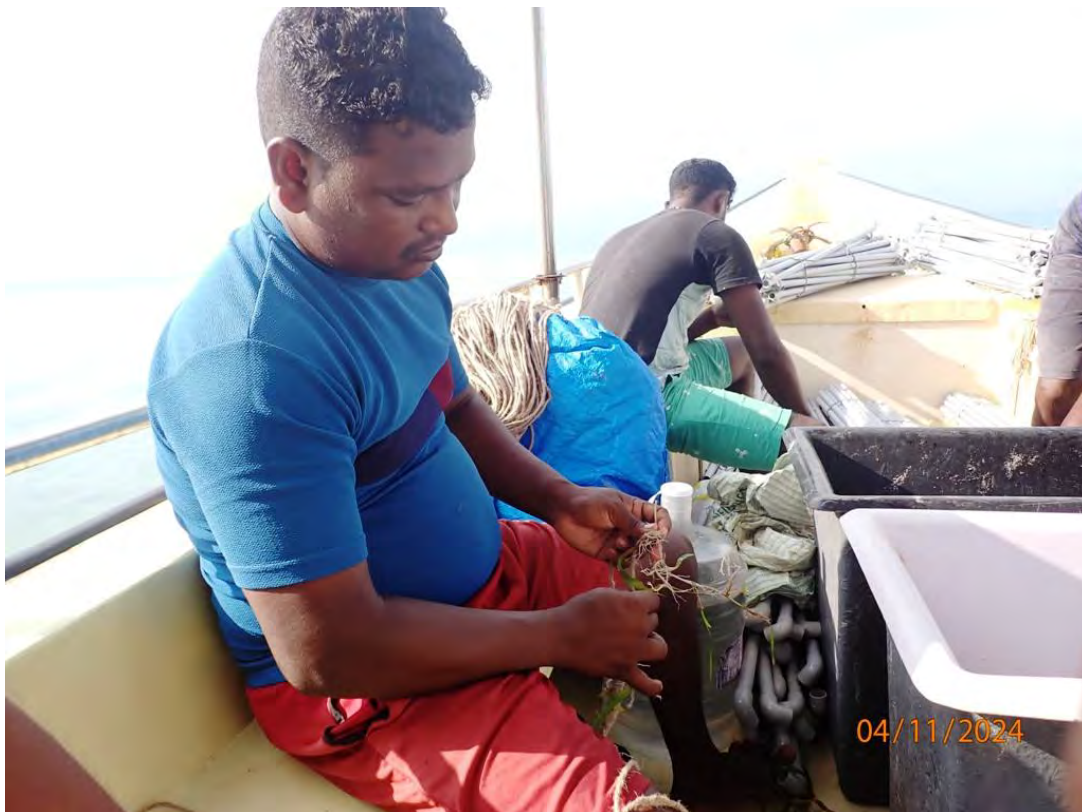
**Fig.18: Seagrass shoots collected from donor site for transplantation**

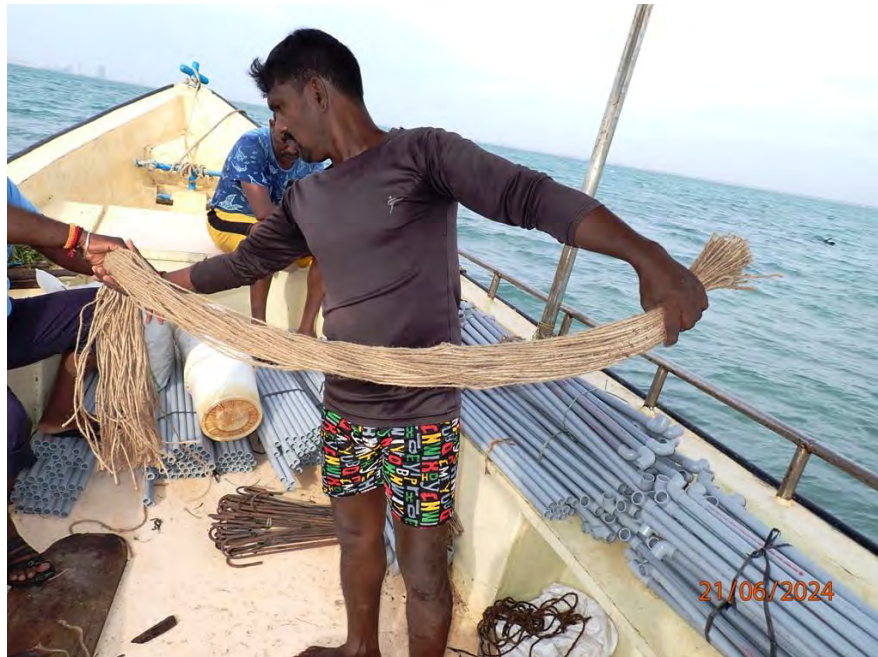
**Fig.19: Jute rope used for tying seagrass shoots**

The collected seagrass shoots were sprayed with seawater and then were tied in jute rope. The jute rope tied with shoots was tied to the frames. In each frame, a minimum of six rows of jute ropes with shoots were tied. In each row, a minimum of 20 shoots were tied (Figs.19-24).

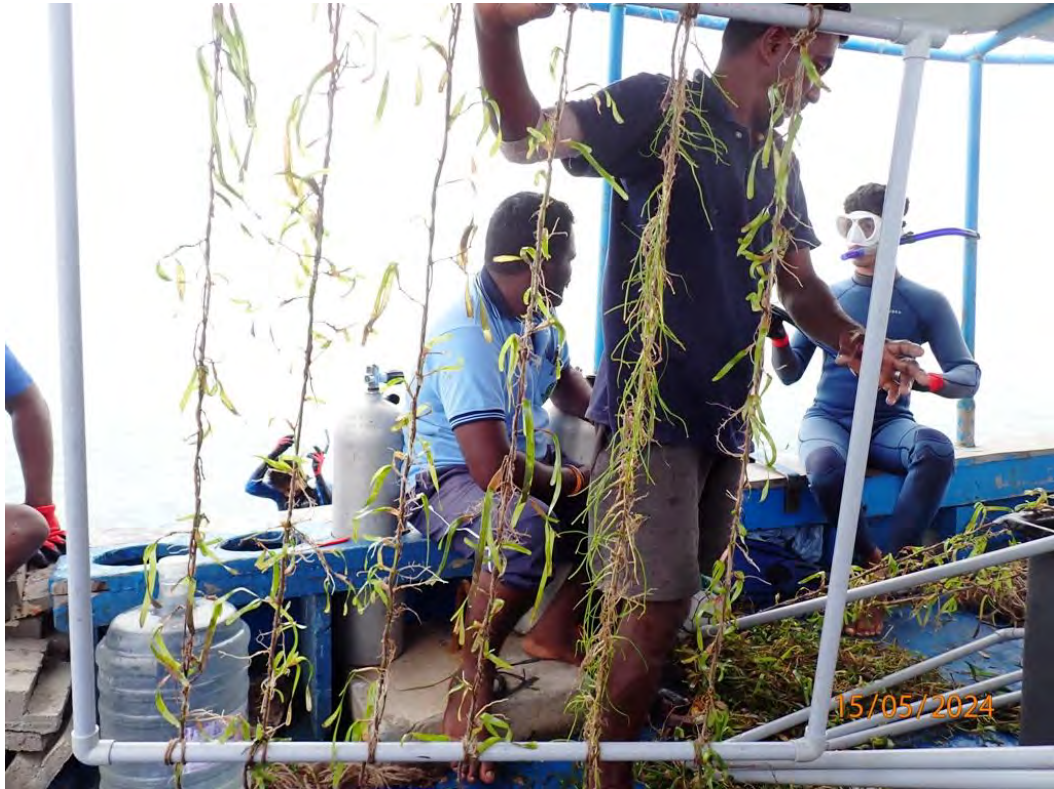
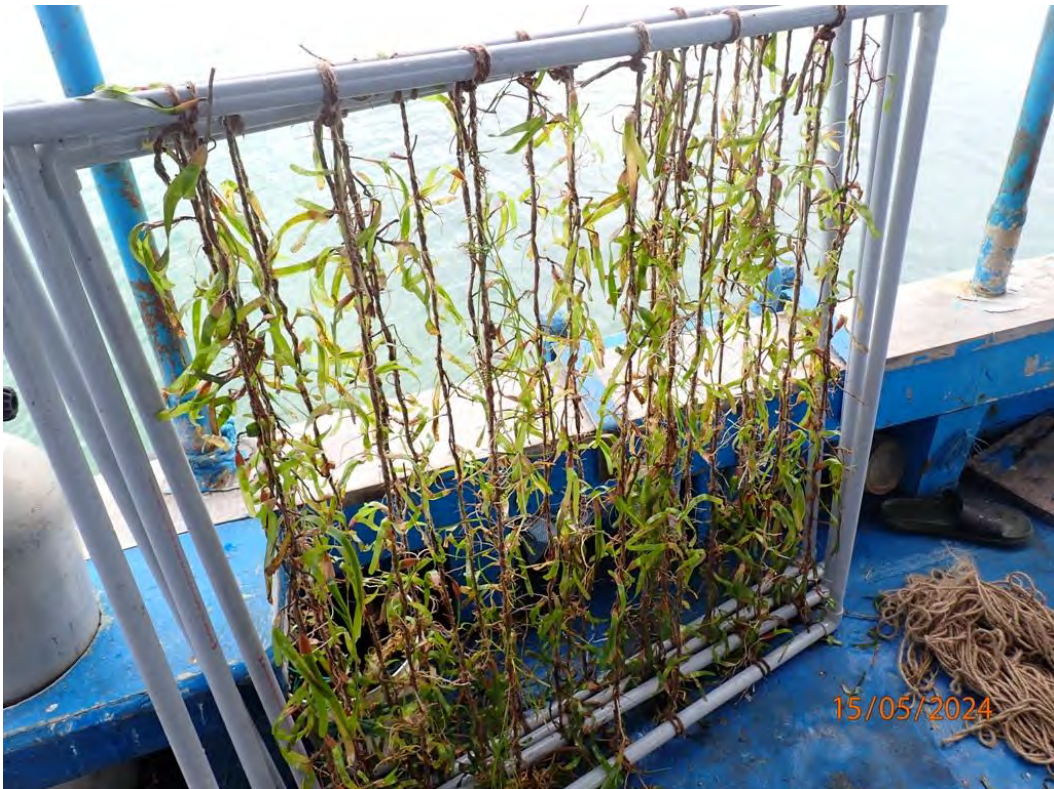
**Fig.22: Transplantation of seagrass shoots on PVC frames using jute rope**

In manual seagrass transplantation method, an apical shoot with intact roots is attached at a regular interval to a biodegradable jute twine, and the twine is tied to a 1 X 1 m PVC quadrat. A minimum of six rows of jute twines are tied firmly with each quadrat with a minimum of 20 shoots per twine. The quadrats and jute twines help in keeping the shoots intact and also safe from being washed away by the waves, tides and current. PVC frames are pre-drilled to make them negatively buoyant by taking seawater in. After taking these quadrats with seagrass transplants under the water, divers place them at the restoration site and nail them firmly using hook-shaped iron rods. It is made sure that the seagrass roots are in contact with the bottom and that disturbance from waves, tides, and currents is minimized. The PVC frames are left in place until the shoots are firmly rooted to the sediments and it is ensured that all the sprigs maintain contact with the seafloor. Altogether 2,000 PVC frames (1 X 1 m) were constructed. Long pipes were cut into desirable size to make 1 X 1 m frame. Initial work was done at the laboratory in Tuticorin and the final fabrication was done in the field. Using SCUBA diving, restoration was conducted in seven blocks within 1 acre of degraded seagrass areas in the two selected sites. Block 1 (site 1) consists of 200 frames while blocks 2-7 consist of 300 each. Block 1 is located slightly far from Koswari Island at a distance of 3 km, whereas blocks 2 to 7 (site 2) lie close to Island within 1 km. Each block consists of 4-8 nos. of clusters with each cluster separated with a distance of about 30 to 40 meters.

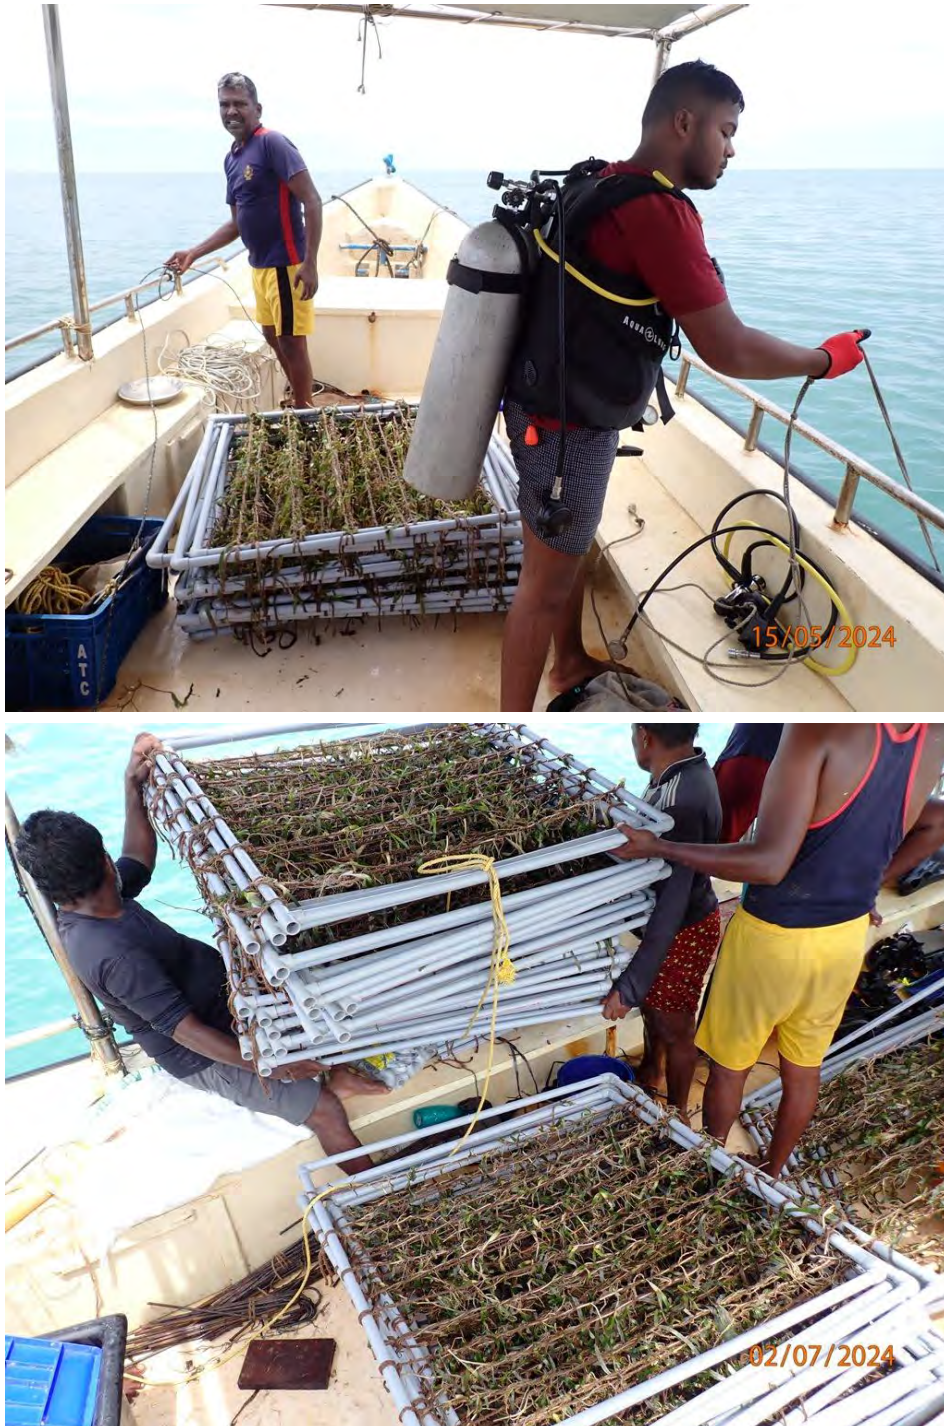
**Fig.25: Transferring PVC frames tied with seagrass shoots to restoration site**

The PVC frames tied with seagrass shoots using jute rope were taken to restoration site using boat (Figs.25-28).

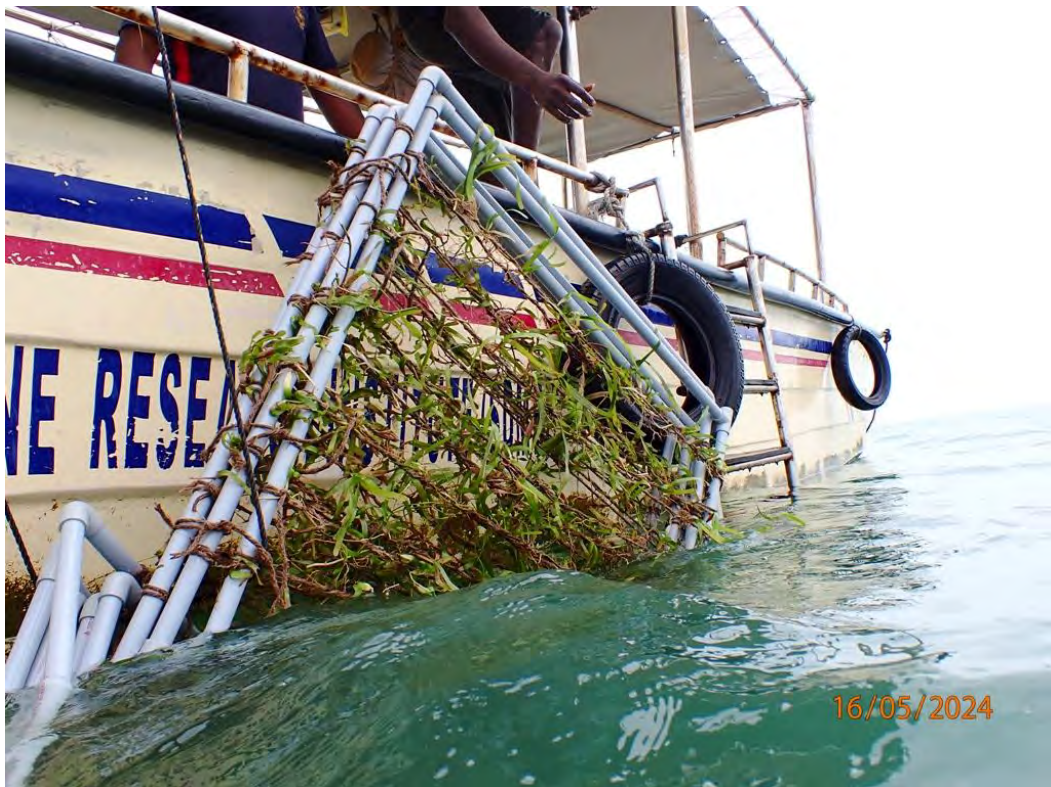
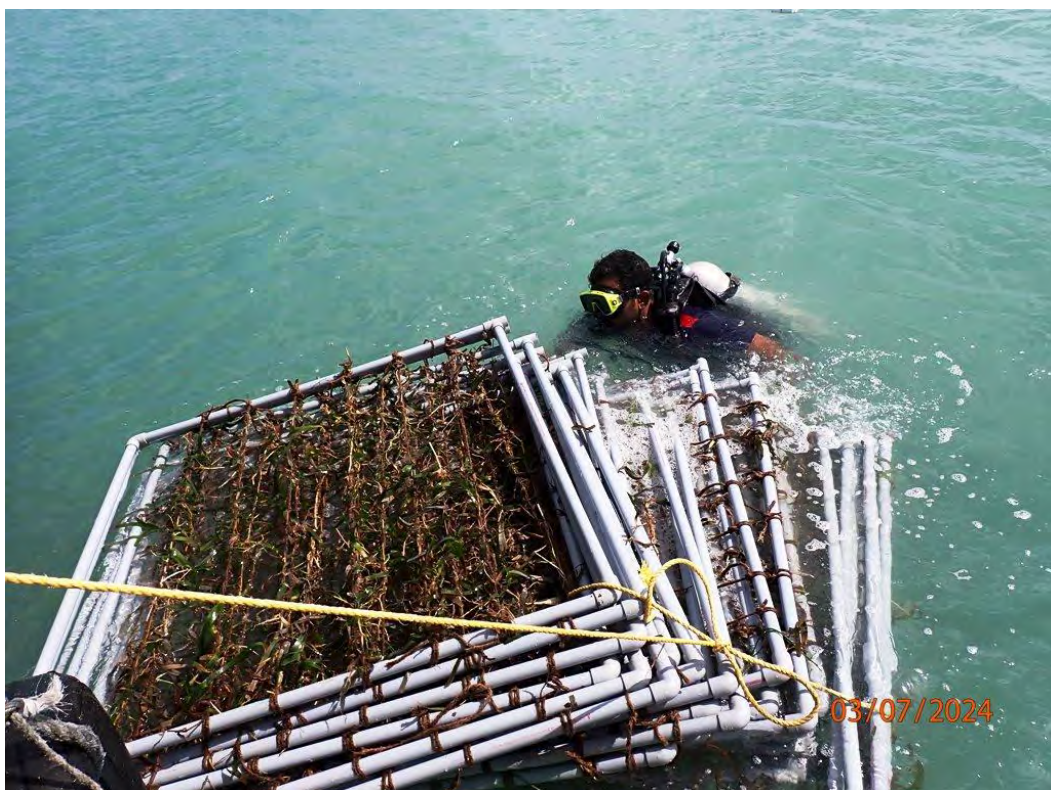
**Fig.26: Transferring PVC frames tied with seagrass shoots to restoration site**

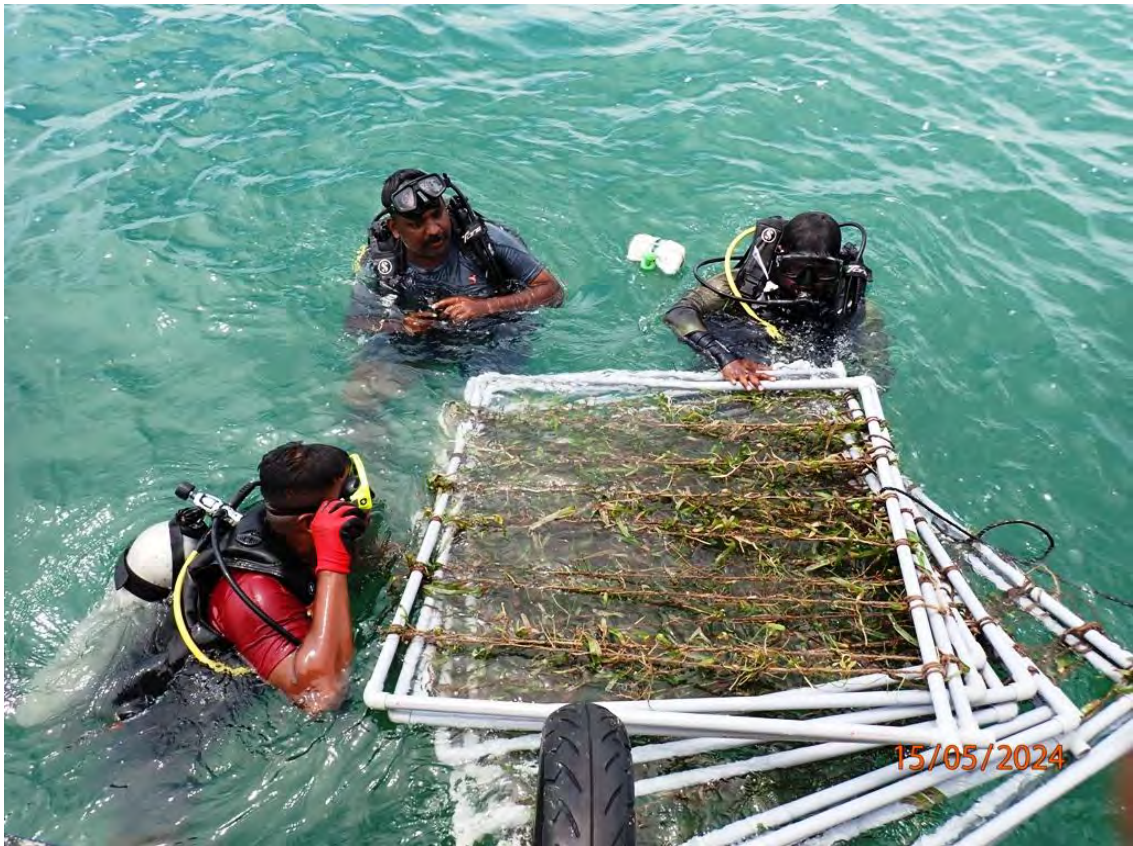
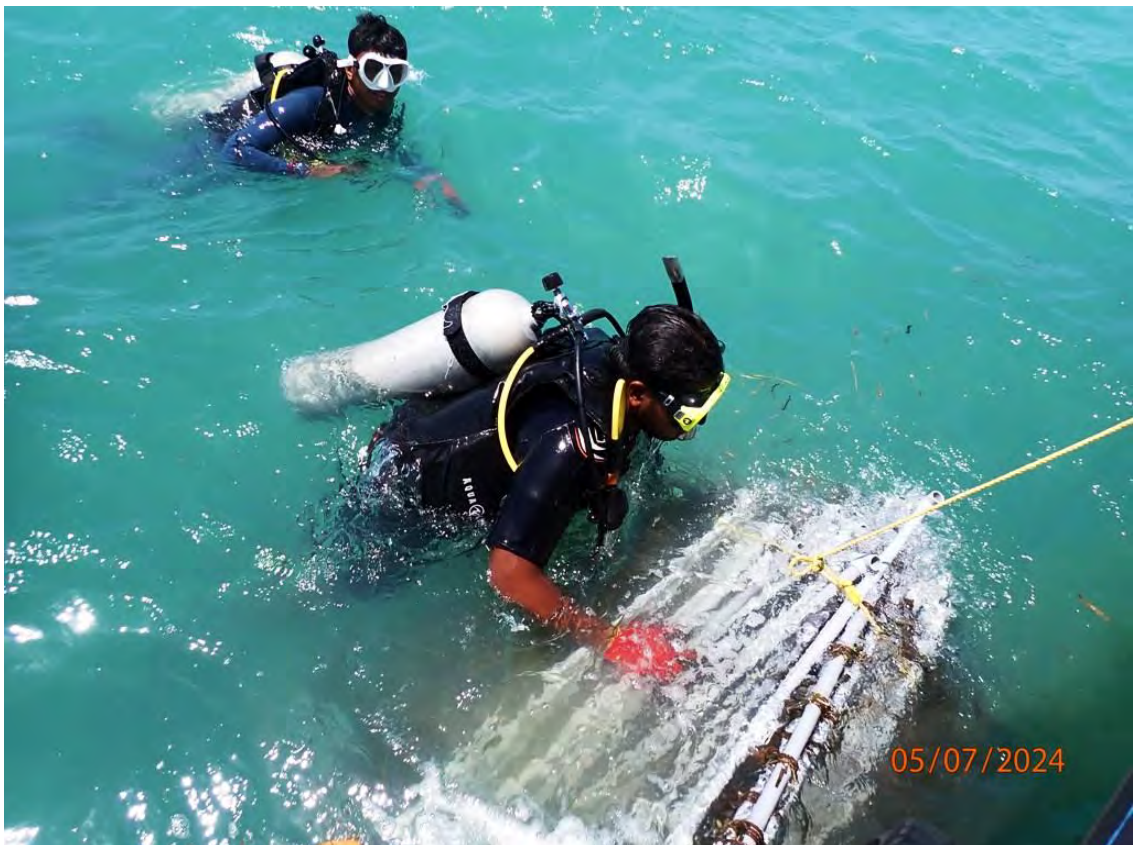
ig.27: Transferring PVC frames tied with seagrass shoots to restoration site

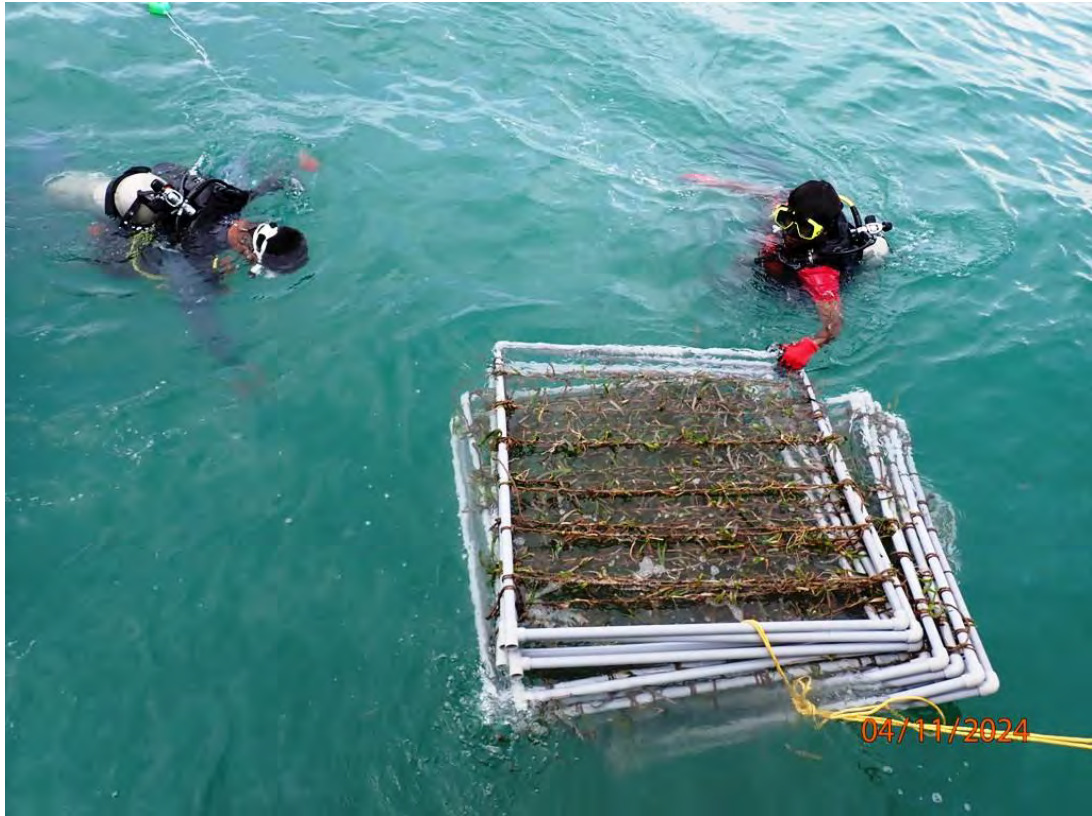
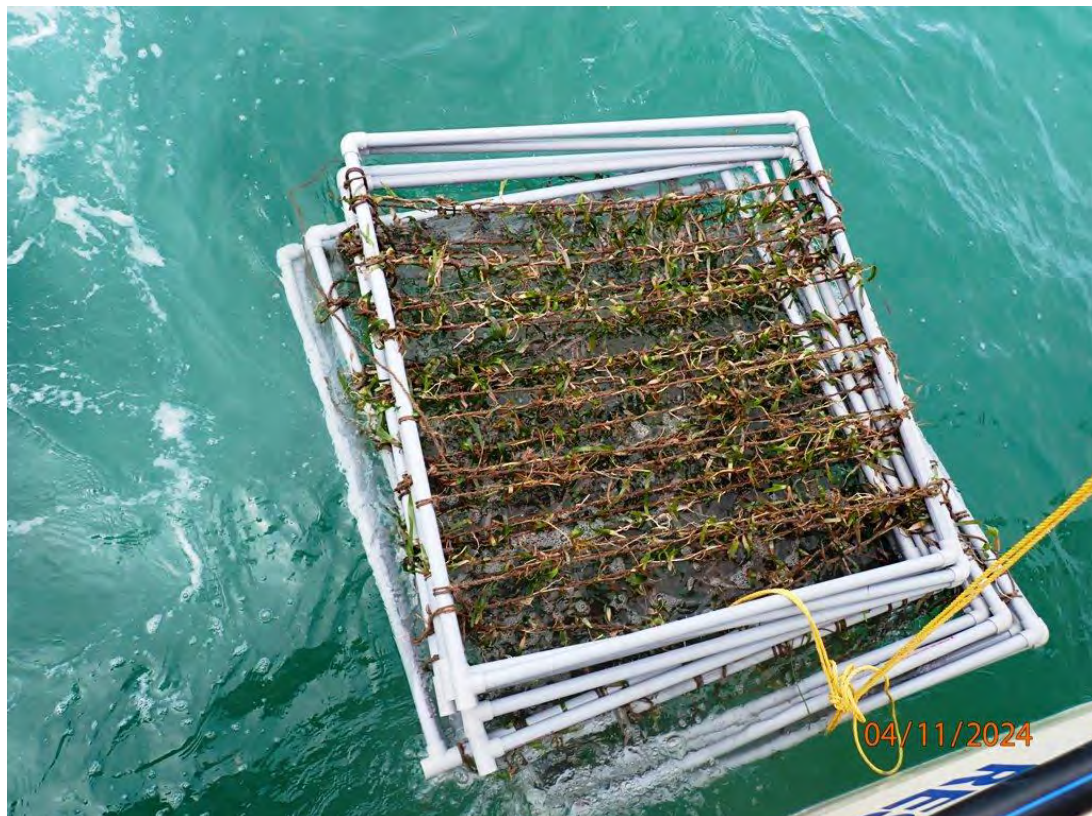
**Fig.28: Transferring PVC frames tied with seagrass shoots to restoration site**

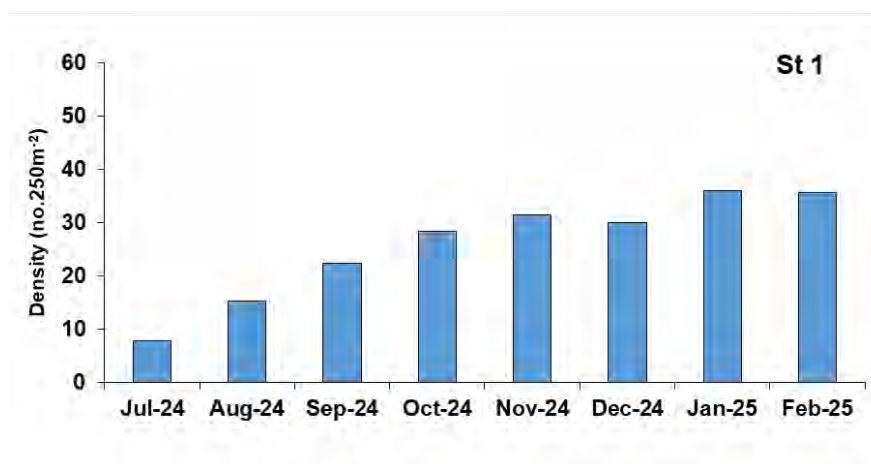
A total of 15 fish species were recorded at station 1 during the study period and the overall density of fish increased from 7.8 to 35.6 no.250<sup>-1</sup> from July 2024 to February 2025 (Fig. 47; Table 8). The most common fish species include *Eubleekeria splendens*, *Parupeneus indicus*, *Terapon puta* and *Siganus canaliculatus*.

**Fig. 47: Fish density at station 1 during the study period**
