**Restoration of degraded coastal wetlands focusing on seagrass meadows in Gulf of Mannar, Tamil Nadu - *to strengthen climate adaptation and to enhance livelihood sustainability***

(Work Order: TNSWA1/25733/2022, Dated 12.02.2024)

## **Final Report**

**Suganthi Devadason Marine Research Institute (SDMRI)  
(Recognized by Manonmaniam Sundaranar University and U.G.C. &  
Recognized Scientific and Industrial Research Organization by the DSIR, GOI)**

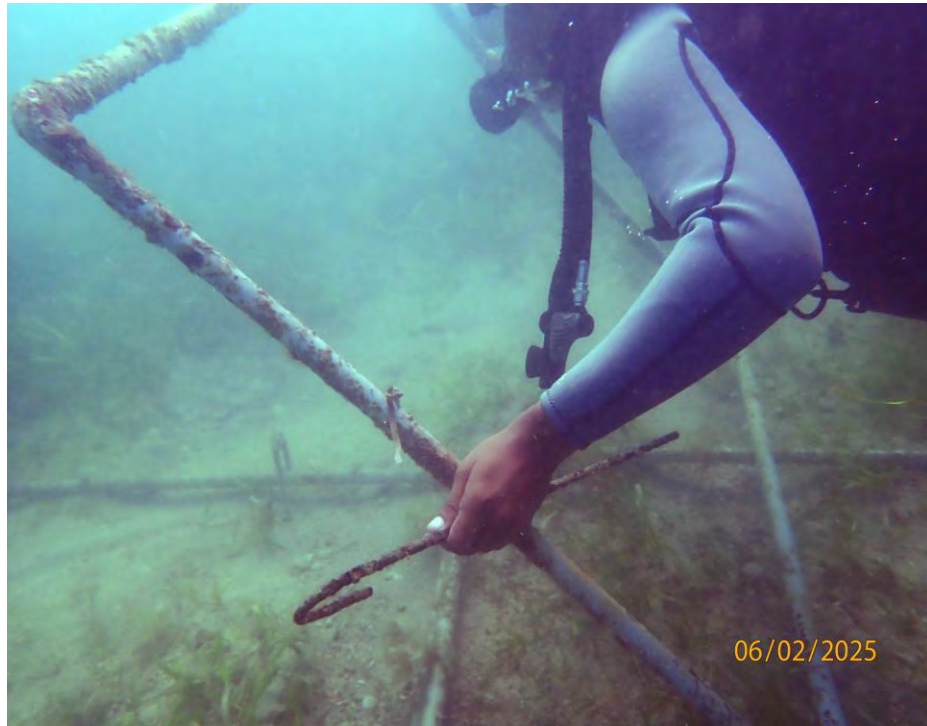
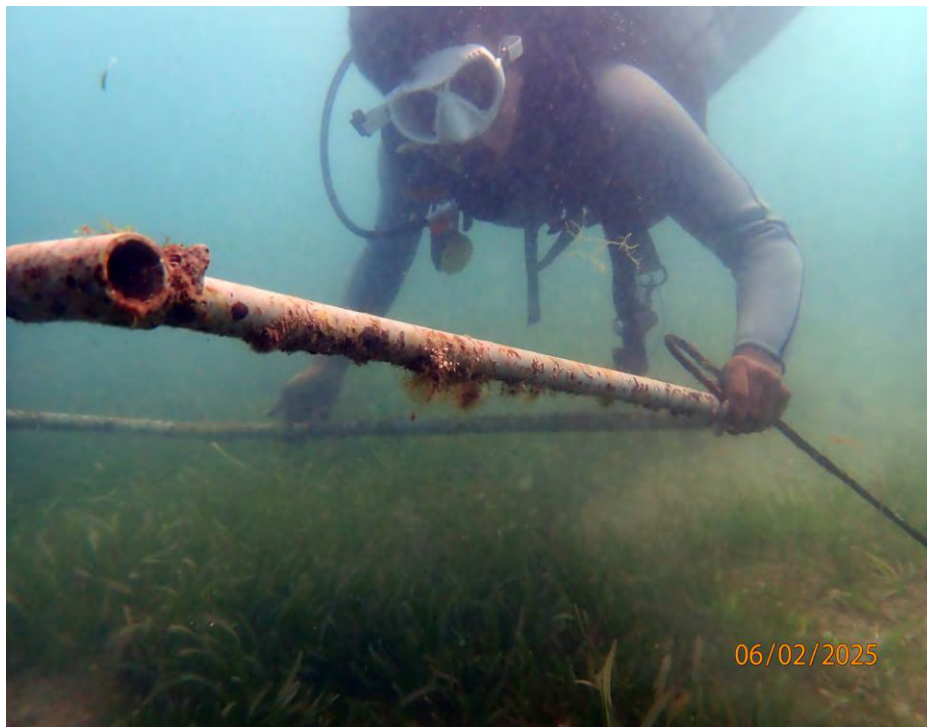
**Fig. 59: Removal of PVC pipes after the establishment of transplanted seagrasses**

After the establishment of seagrass shoots, PVC pipes were removed from the sea bottom in February 2025.

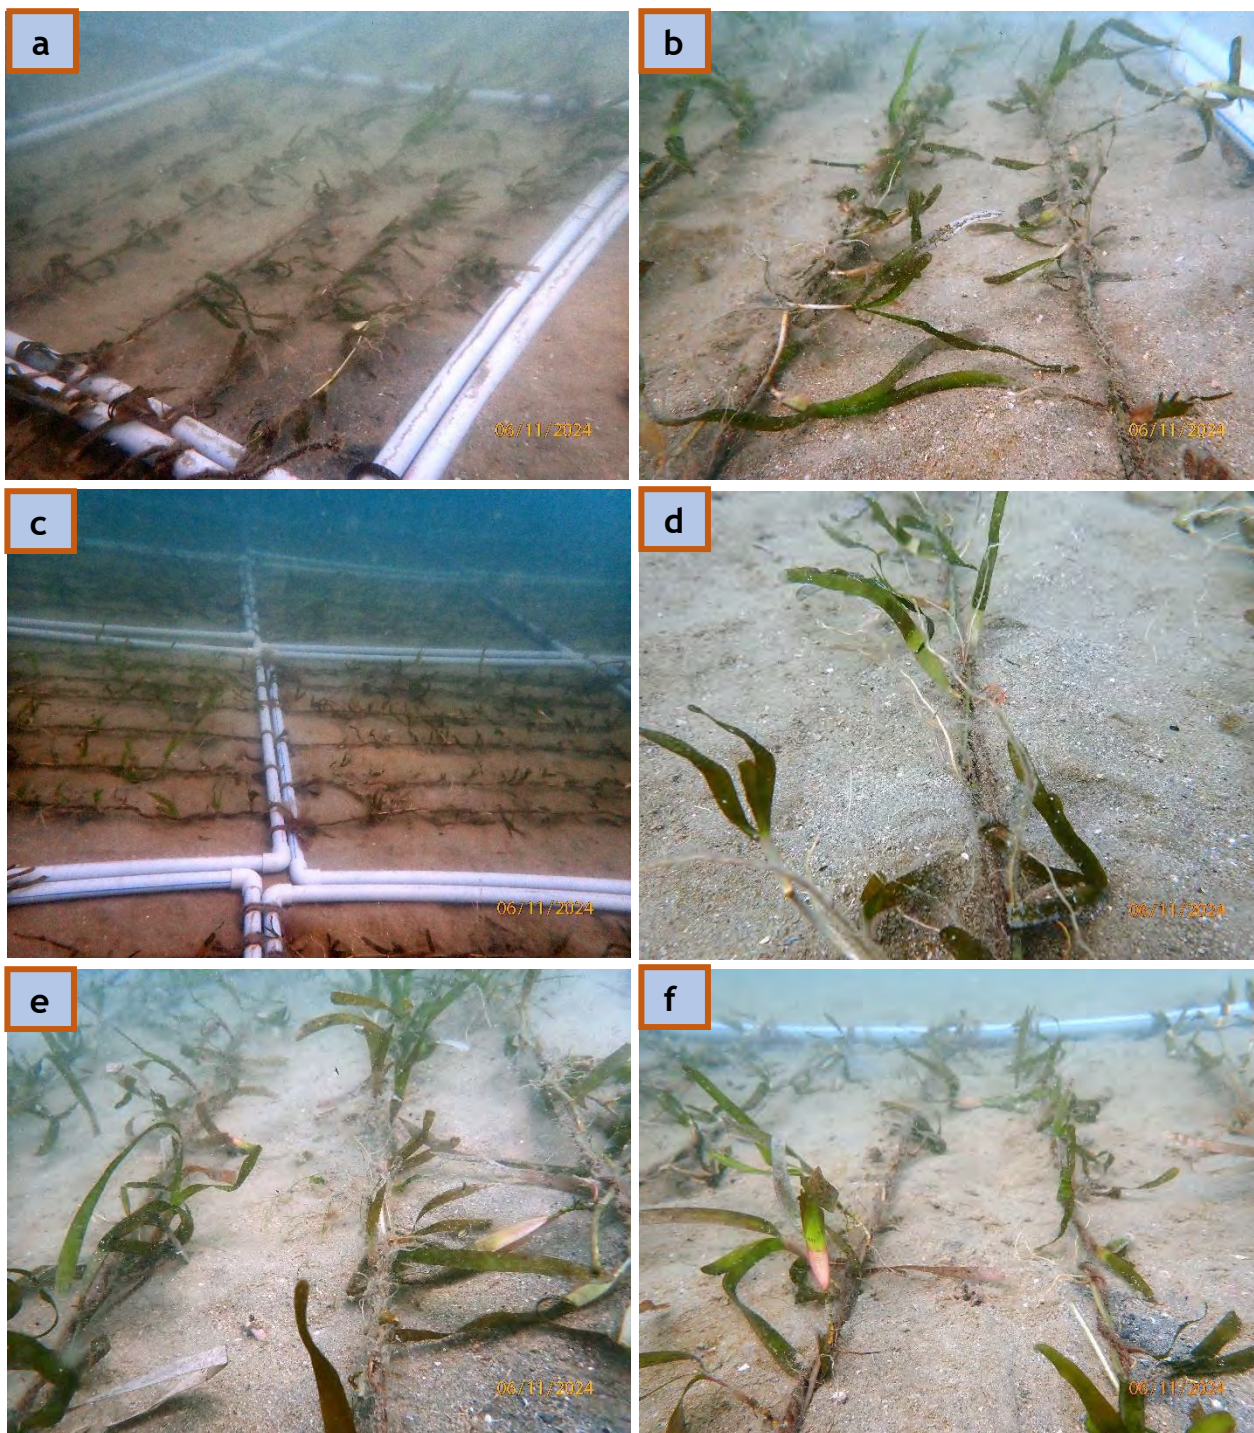
(a) & (b) *Oceanania serrulata* (c) restored seagrass species (d) *Thalassia hemprichii* (e) & (f) *Oceanania serrulata*

Plates 3 & 4: Underwater photos of seagrass restoration site after four months

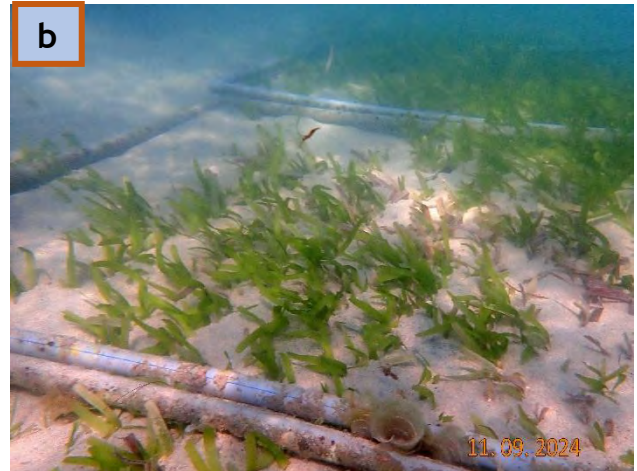
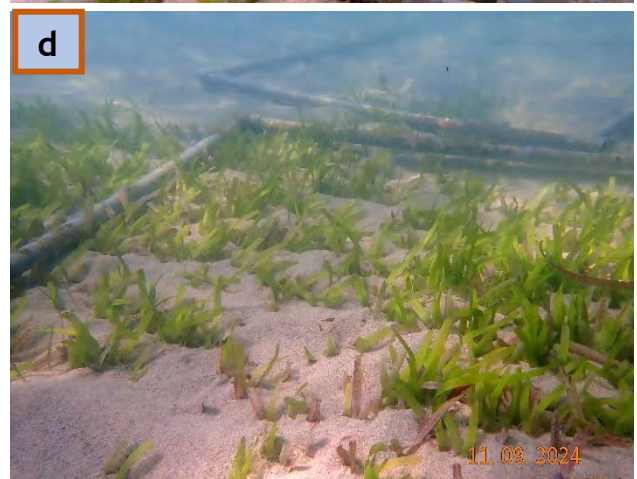
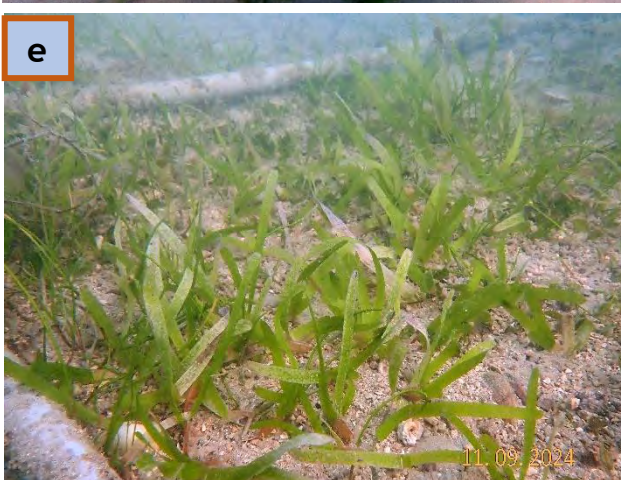
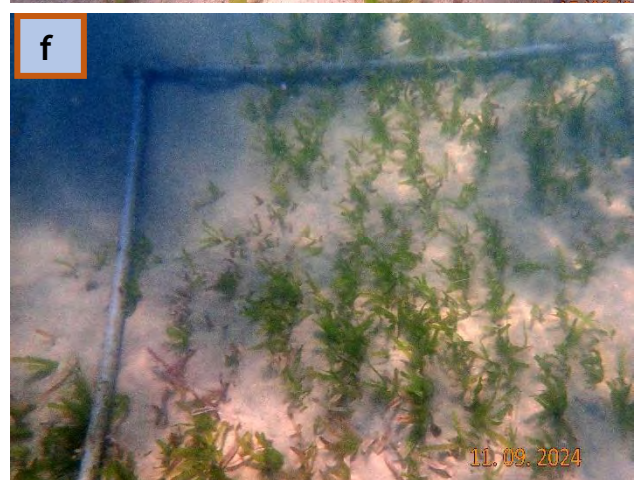
(a),(b), (c),(d) *Oceana serrulata* (e) *Thalassia hemprichii* (f) *Oceana serrulata*

Plates 5 & 6: Underwater photos of seagrass restoration site after eight months

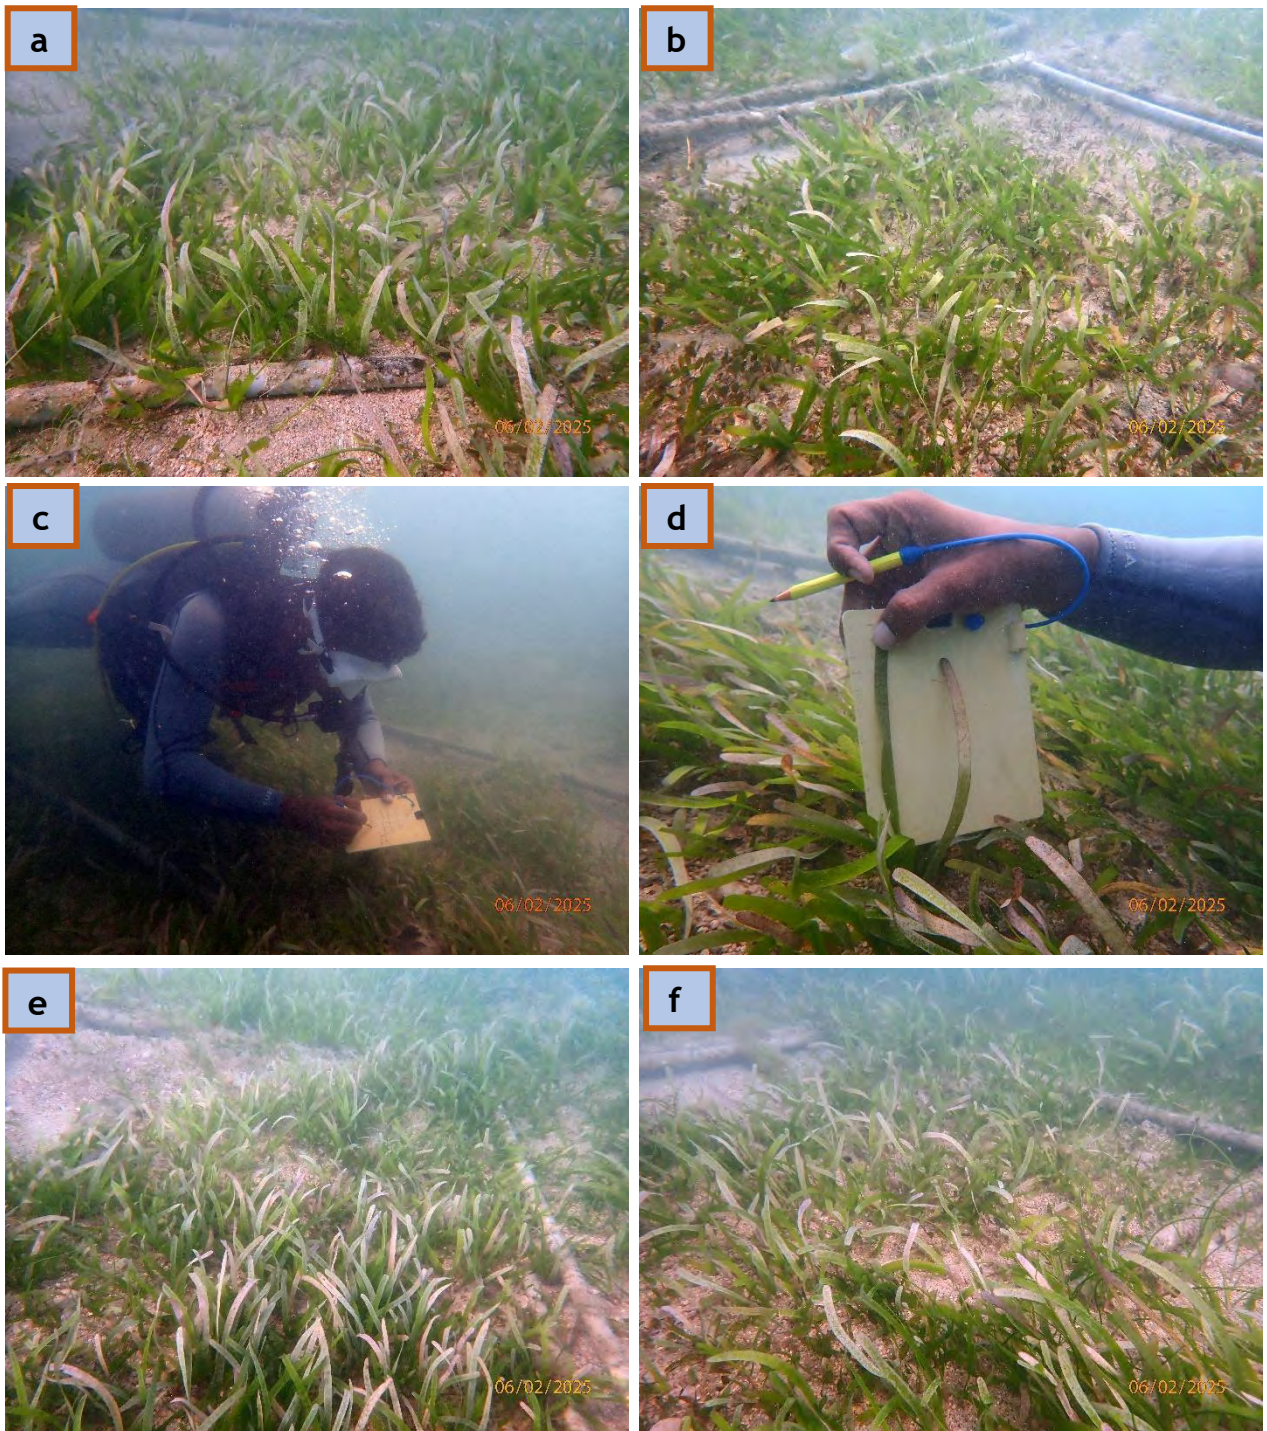
(a),(b), (c),(d), (e) and (f) *Oceana serrulata*

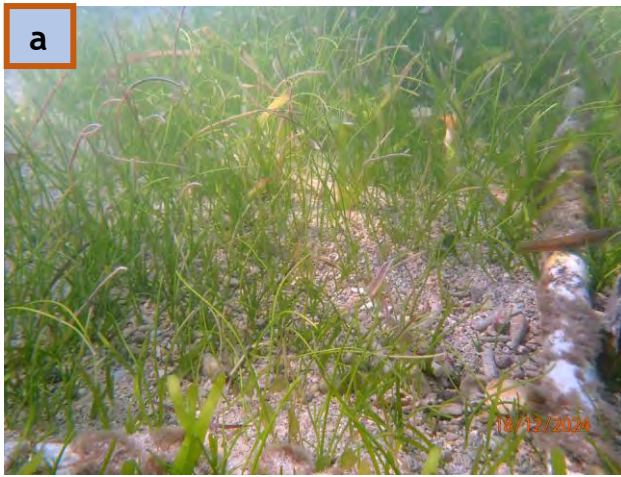
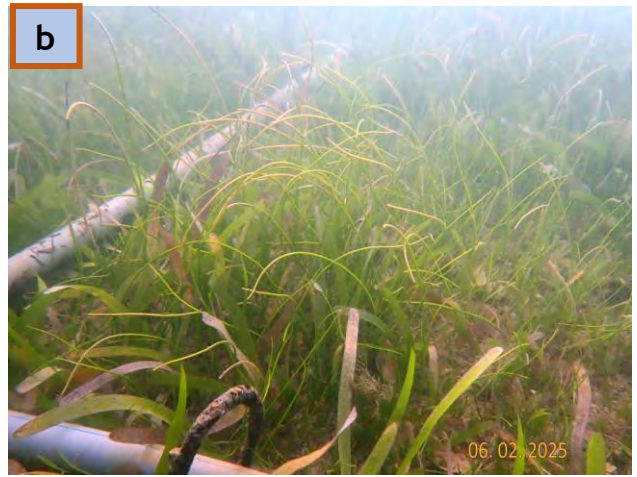
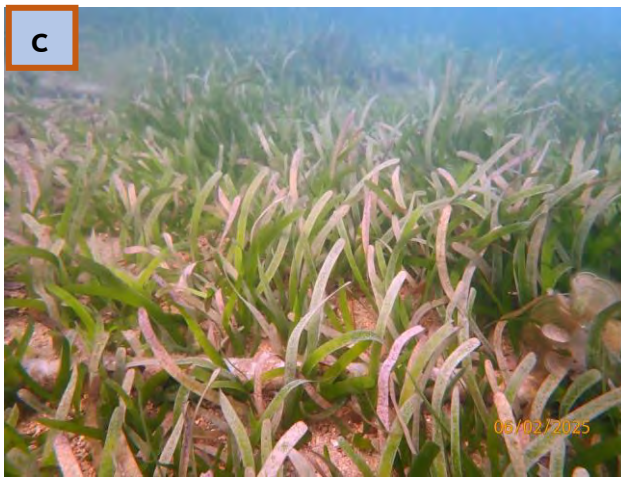
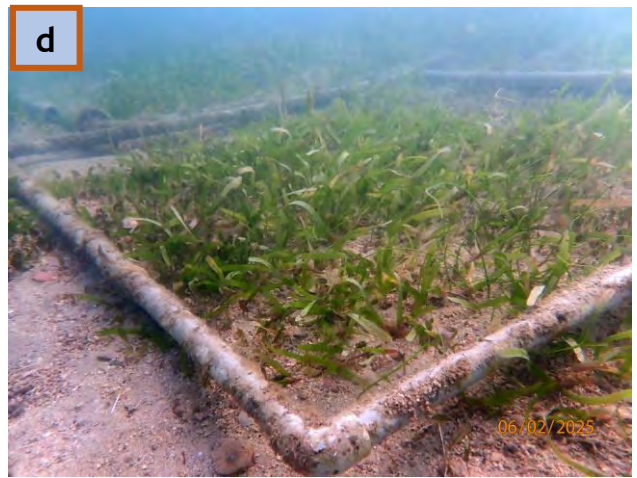
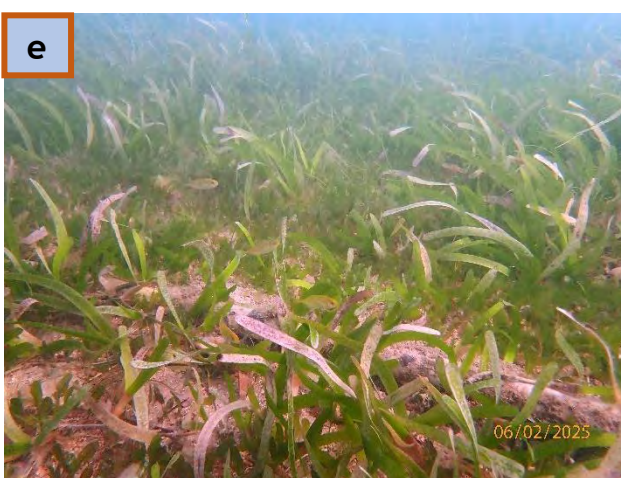
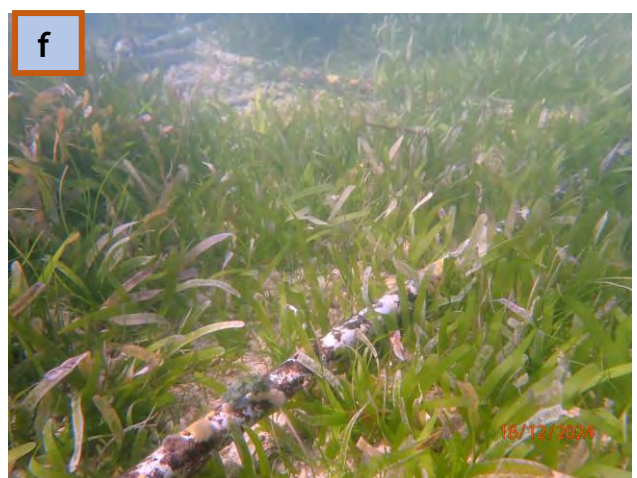
(a) & (b) *Oceana serrulata* and *Syringodium isoetifolium* (c), (d), (e) and (f) *Oceana serrulata*

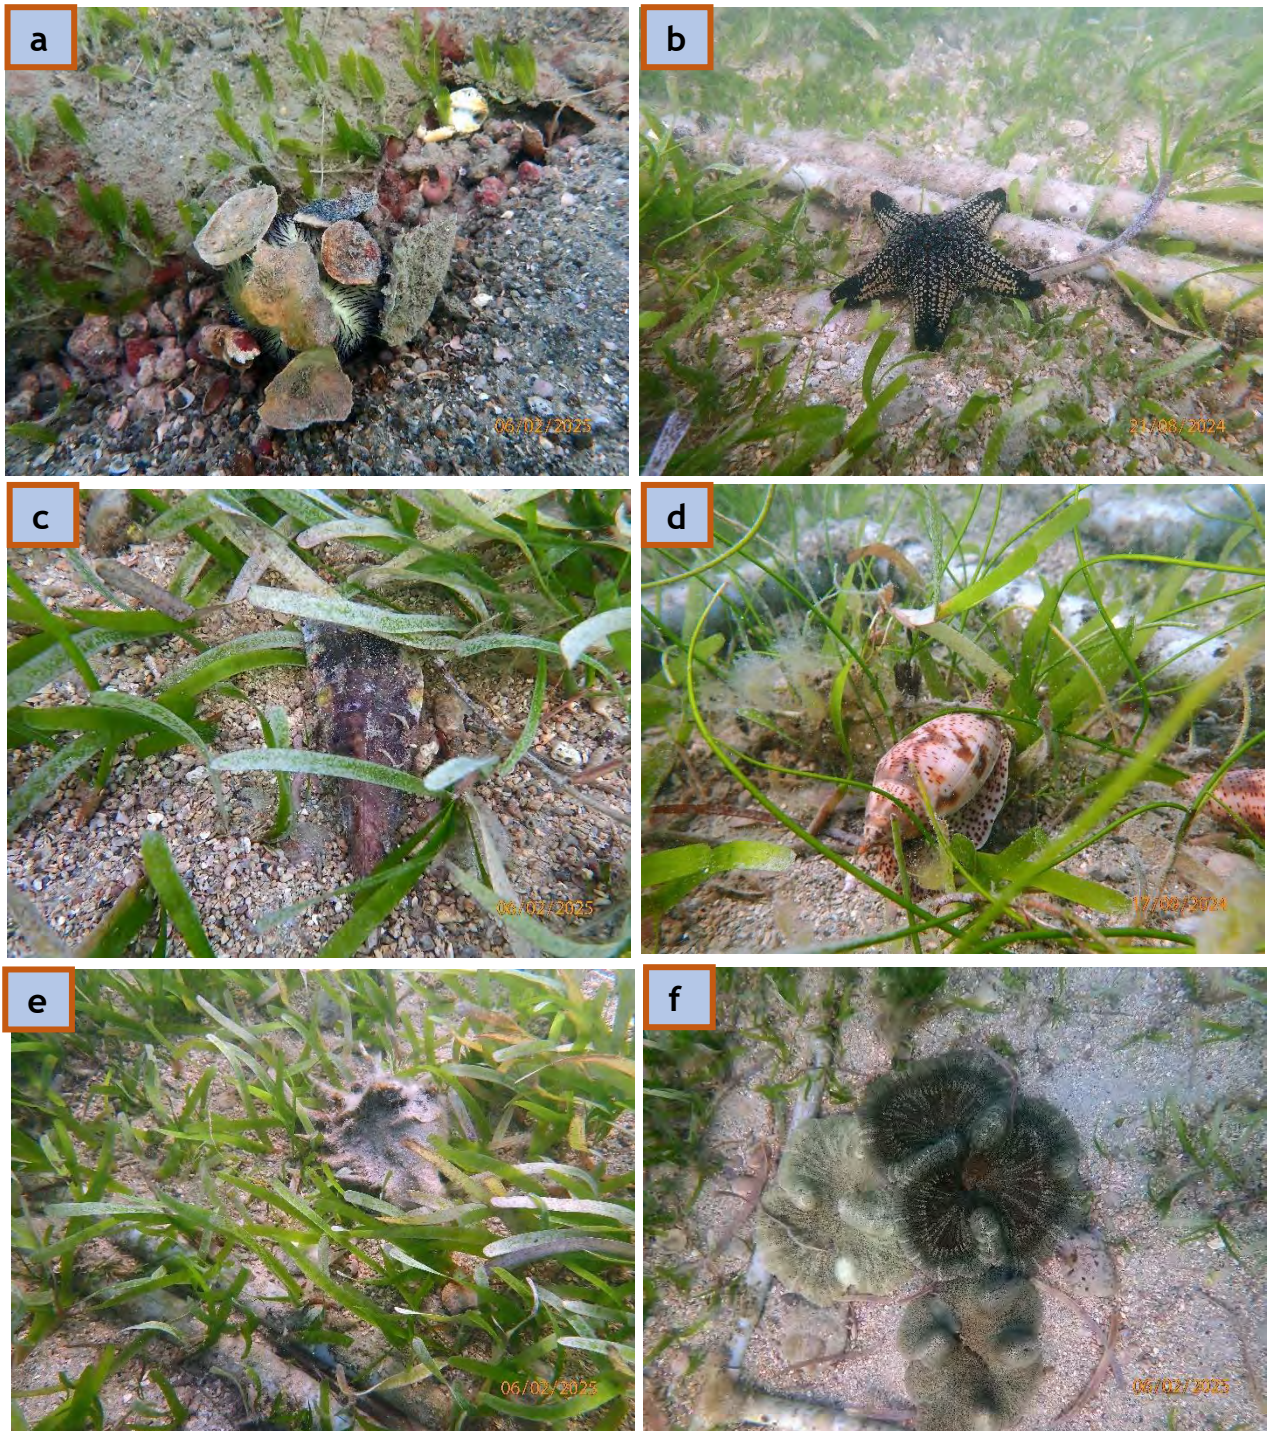
Plate 8 & 9: Observed associated benthic macrofauna in seagrass restoration sites in Koswari Island

(a) *Salmacis virgulata* (b) *Oceana serrulata* (c) *Pinna* sp. (d) *Harpulina lapponica* (e) *Lambis lambis* (f) *Stichodactyla* sp.

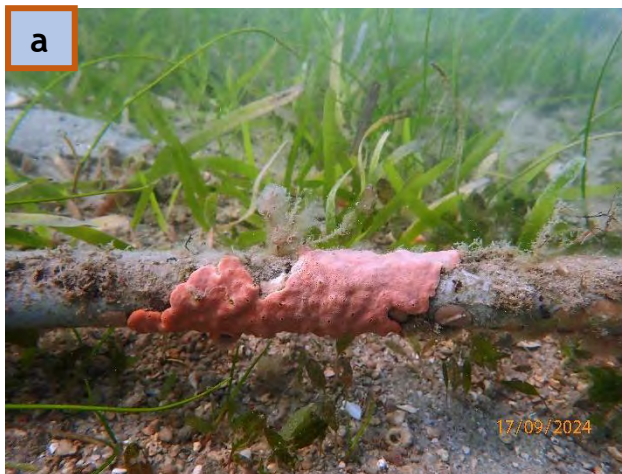
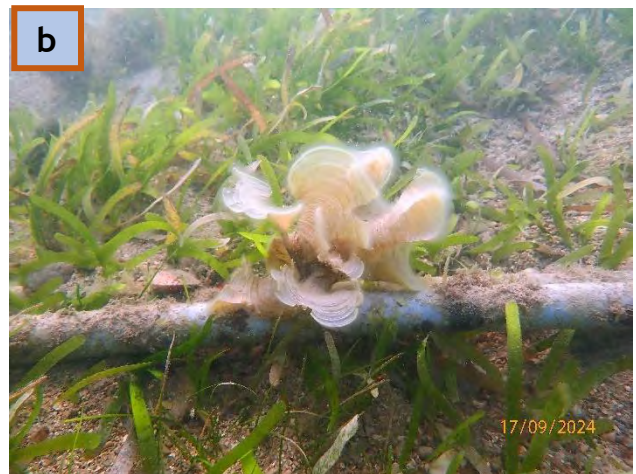
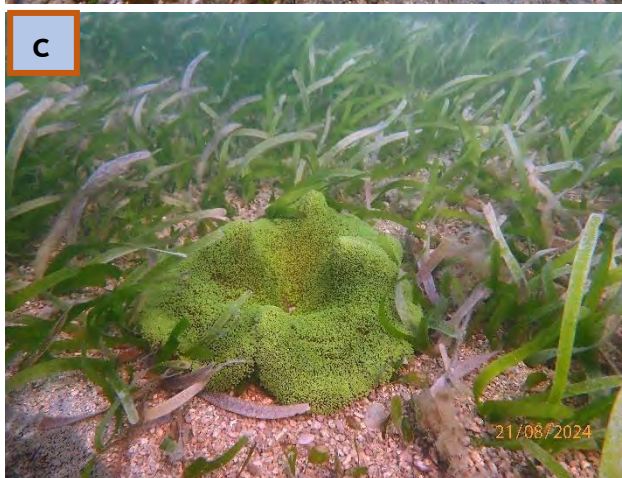
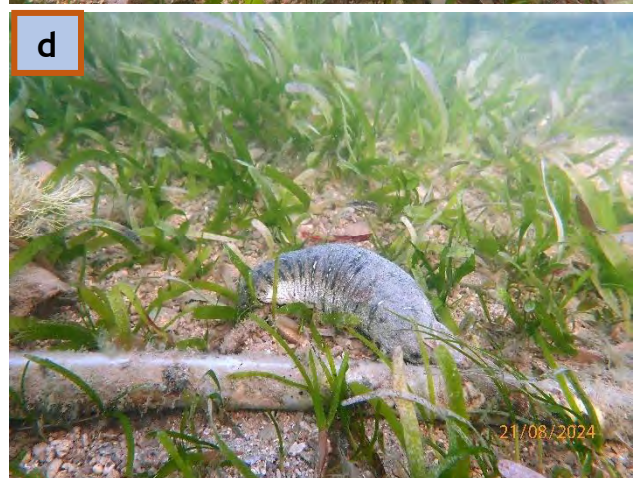
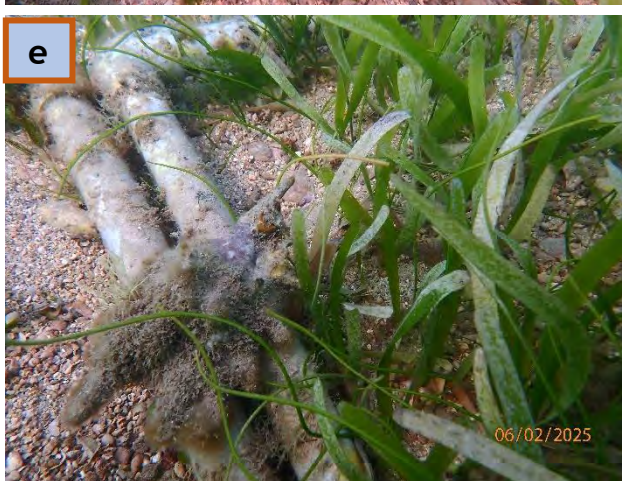
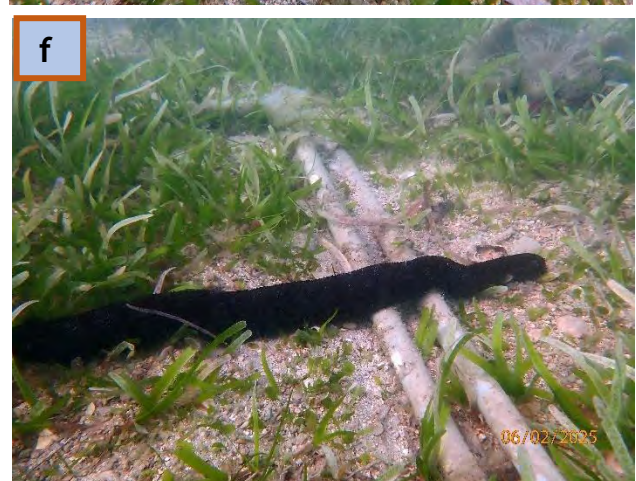
(a) *Didemnum* sp. (b) *Padina* sp. (c) *Stichodactyla* sp. (d) *Holothuria scabra* (e) *Lambis lambis*  
(f) *Holothuria atra*
